Fiberglass Deck Repair—Part I

Replacing damaged balsa core

By Bruce Niederer

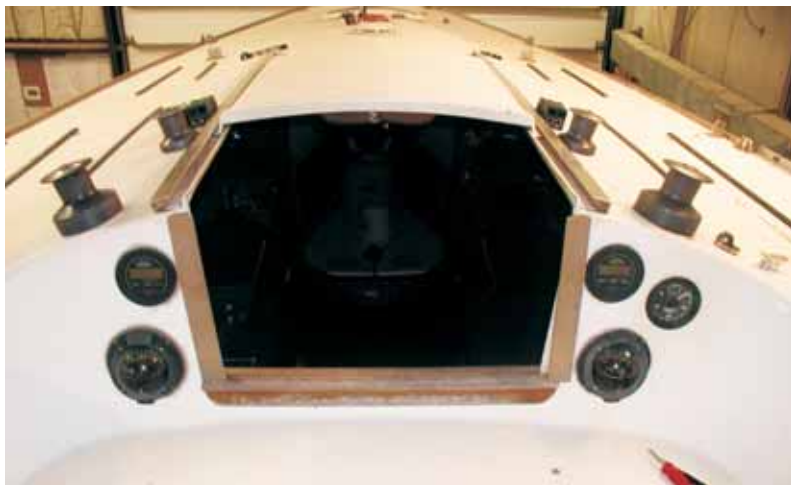
Below—Before removing the hardware, it looked like a straightforward project.

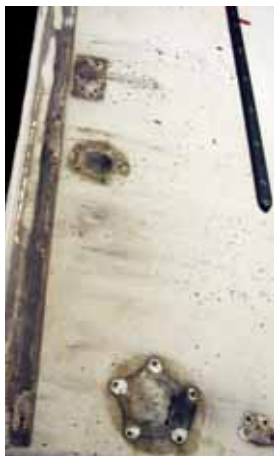
As I started drilling the oversize holes, my project expectations headed south. There are tracks for the #3 Jib just behind the chainplates, and drilling these holes oversize revealed that the balsa wood coming out was black and wet. This is bad. When I used another technique where a bent nail or Allen wrench is mounted in a drill motor and used to ream out more core material than just the diameter of the hole, water actually splashed out on deck. #@*%! This was worse. I found the same condition where the middle reaching track for the #1 Genoa is mounted (*bottom far left*). So now, my new non-skid deck replacement would have to include removing and replacing the bad core—on both sides of the boat, of course.

Bottom left—Removing the hardware, revealed the damaged core.

To replace the core involves removing the fiberglass skin to expose the core. This can be done either from the topside or below deck. In my case, since the deck was getting new non-skid anyway, the repair would be easier from the topside. Using a circular saw, shallow cuts were made just deep enough to cut through the top skin to open up the damaged area once the skin was removed. A series of cuts were needed, enlarging the area incrementally until good core was reached. The bad core that didn't come out with the glass skin was removed with a chisel (*left*).

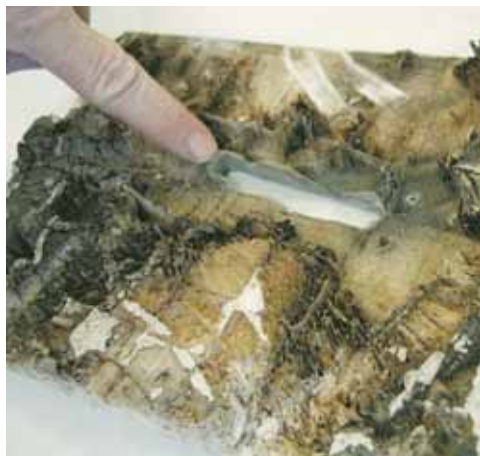
It may seem odd that rotten, wet balsa was still bonded securely enough that it had to be removed with a chisel. Many folks have the misconception that balsa is a poor choice for

Bottom right—Surprisingly, much of the damaged core was well bonded to the glass skin, as it was to this section of skin around the chainplate.

core material, that it will act like a sponge and disintegrate quickly if water gets to it. This is not the case. End grain balsa retains a high percentage of its compression strength and structural integrity for a surprisingly long time after it gets wet exactly because of the grain orientation. Water soaks in much more slowly perpendicular to the grain than it does with the grain—and the end grain is bonded to the skins, so it's inaccessible. There was no softness in the deck or any indication of the core damage in the deck while the boat was in use last season. Eventually there would have been, but since the boat is 20 years old, I was very impressed with how well the balsa performed over the years. Yes, it's heavier than foam, but foam cores have their own weaknesses to be dealt with, and it's wise to replace whatever core was originally used with the same material. Assuming the skins are the same, a balsa core laminate would be stiffer than a foam core laminate due to balsa's higher density and shear modulus. Also, according to the Forest Products Laboratory ratings of numerous wood species regarding rot resistance, balsa has the same rating as okoume and meranti: mildly resistant. Okume and meranti are widely considered a good choice for marine applications especially when properly coated and installed. So, application and technique are the key factors in using any mildly resistant species of wood, balsa included.
