Fiberglass Deck Repair—Part I

Replacing damaged balsa core

By Bruce Niederer

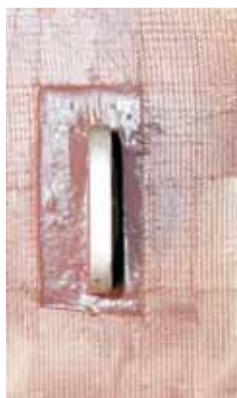
With the larger piece of fabric going into the repair area first, followed by the smaller one, only the edges of the fabric are abraded when the repair is cured and sanded.

The repair patch technique mentioned starts with the 12:1 bevel that was ground before the core went in. Then, two pieces of 738 glass were cut to shape for each repair area. The bottom, or first piece in, got cut so that it fit about 1/2" smaller than the outer edge of the bevel around the circumference of the repair. The top piece was cut so that it was about 1"–1 1/2" smaller around the same circumference. Using WEST SYSTEM® 105/206 and a squeegee, the two patches were laminated into each repair area, the larger piece going in first followed by the smaller one (*bottom*). We are very confident based on testing done at GBI that this repair technique (described in detail in Chapter 4 of 002-550 *Fiberglass Boat Repair & Maintenance*) will produce the strongest repair possible. Once again, 879 Release Fabric was used to firmly squeegee the repair laminate in place, to compact the fibers, and to create a no-prep surface for fairing.
